METALLOGRAPHIC EXAMINATION OF SOLDERING OF MULTILAYER
BOARDS FOR AIRLOCKReport 061-015-76 Model Airlock

METALLOGRAPHIC EXAMINATION OF SOLDERING OF MULTILAYER
BOARDS FOR AIRLOCK

The object of this test was to evaluate the solder connections of components on multilayer boards. This test became necessary when Electro-Mechanical Research (EMR) Co. requested a deviation from MDC. P.S. 22800 in soldering components on multilayer boards. EMR indicated that incomplete solder flow into the plated holes occurs because of the heat sink created by eleven copper layers, ground planes, and shields.

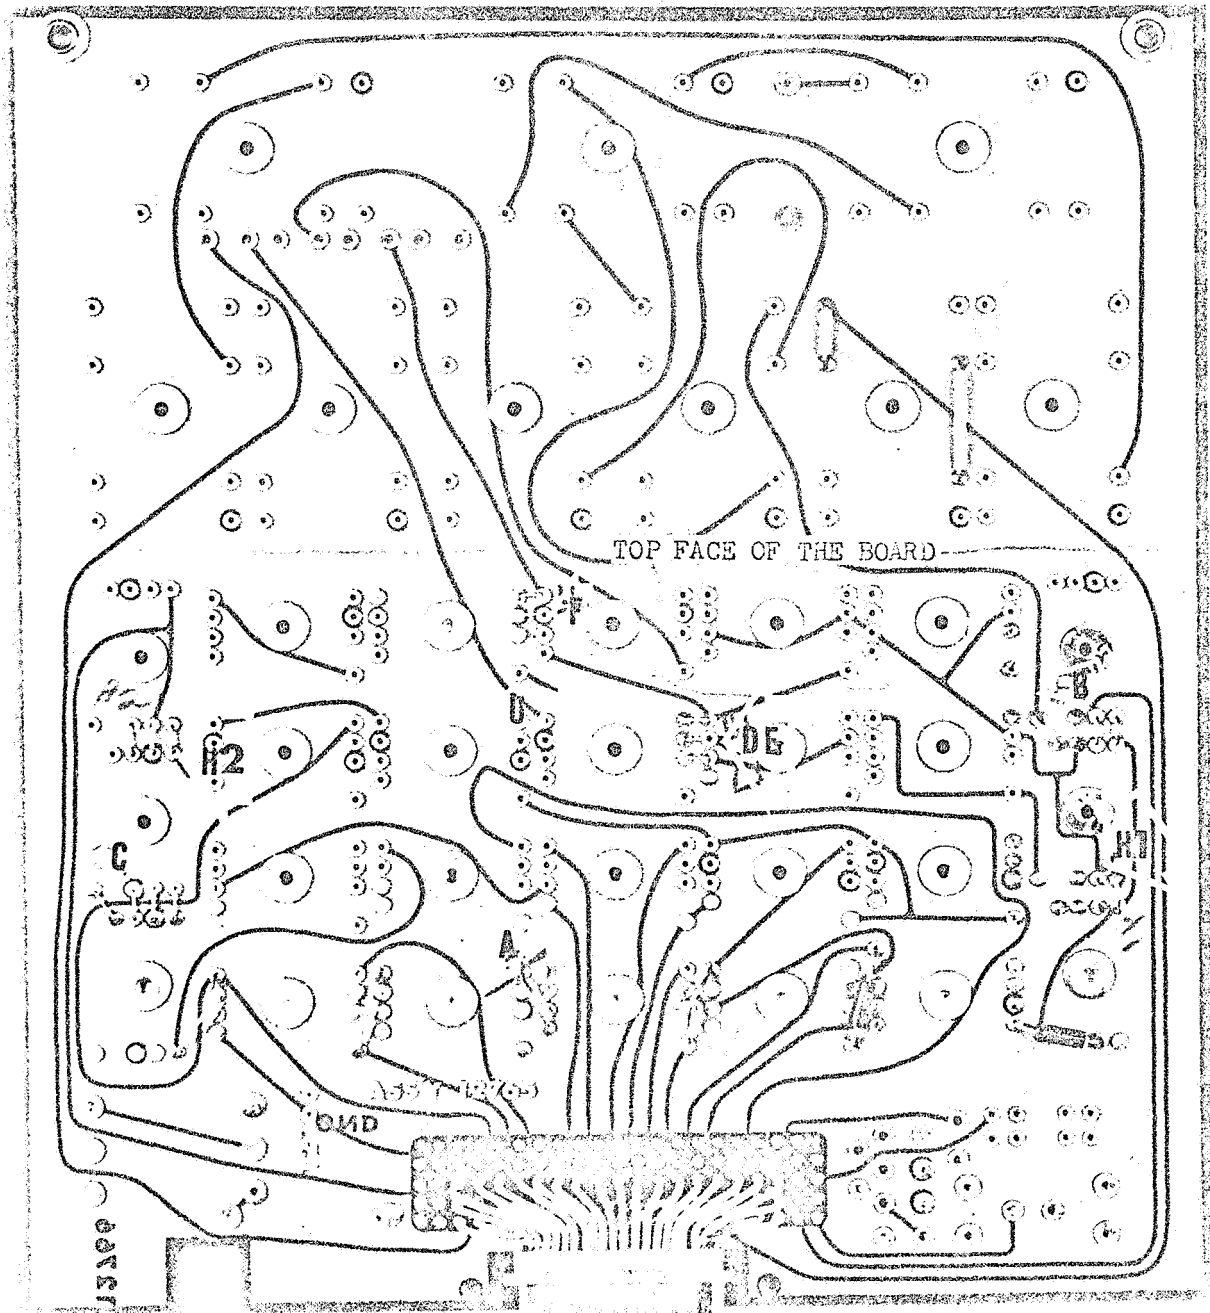
FIGURE 1

AS-RECEIVED CIRCUIT BOARD (THE CONNECTIONS TO BE SECTIONED ARE MARKED WITH ARROWS)

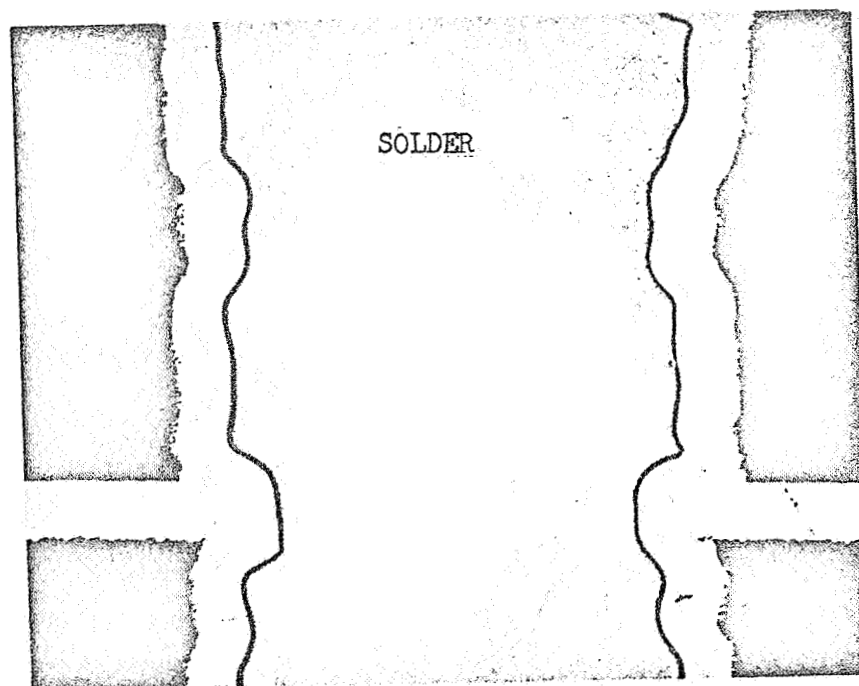
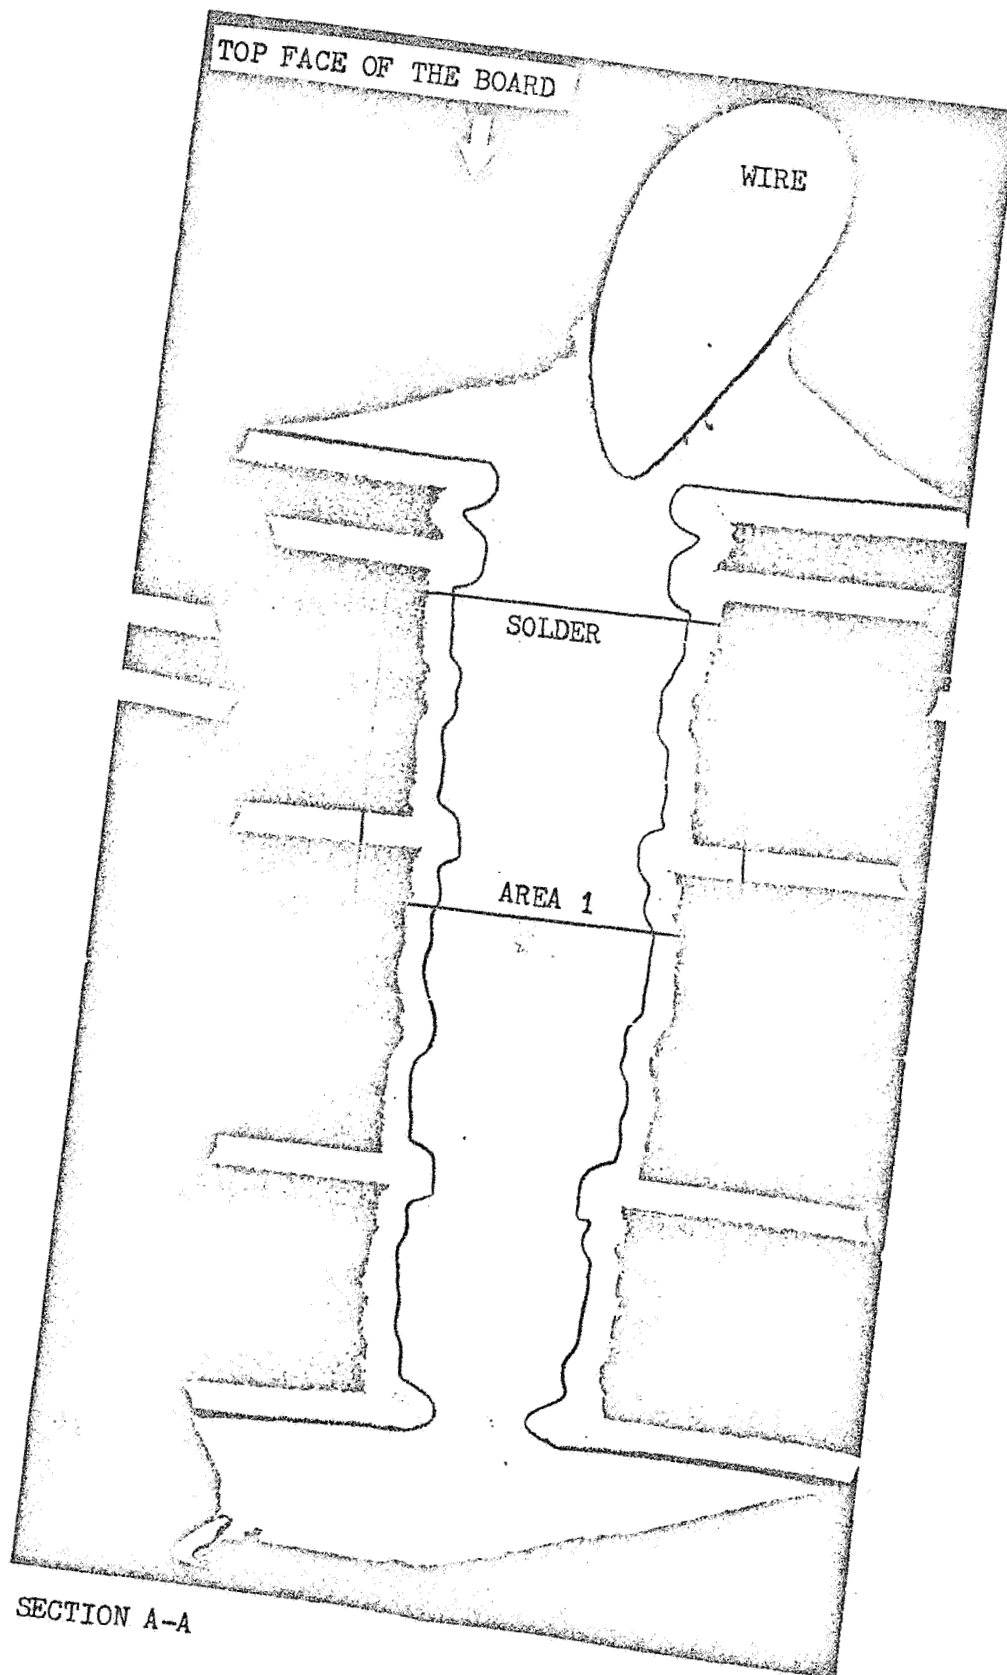
FIGURE 2

CONNECTION A SHOW

COMPLETE SOLDER FLOW

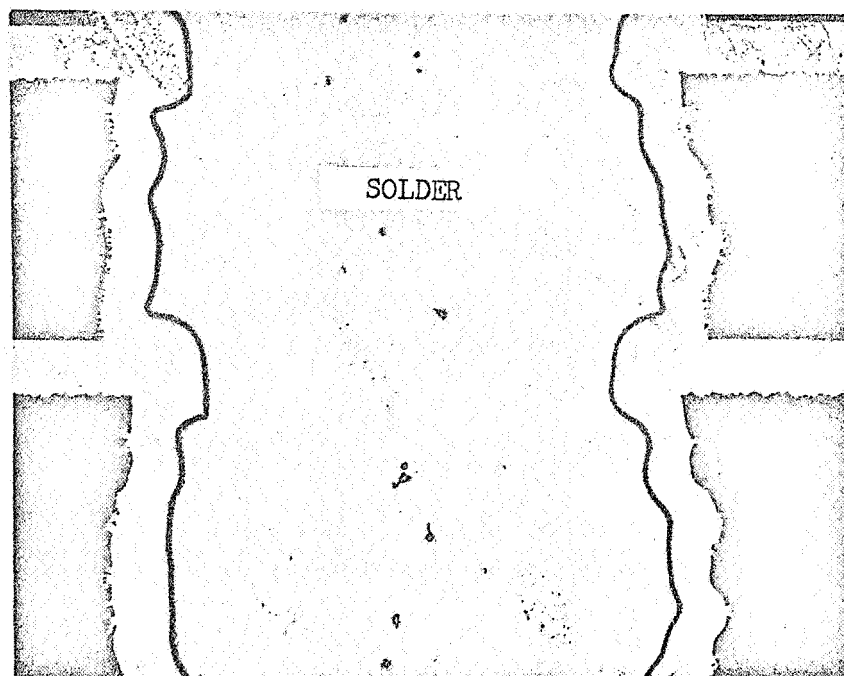
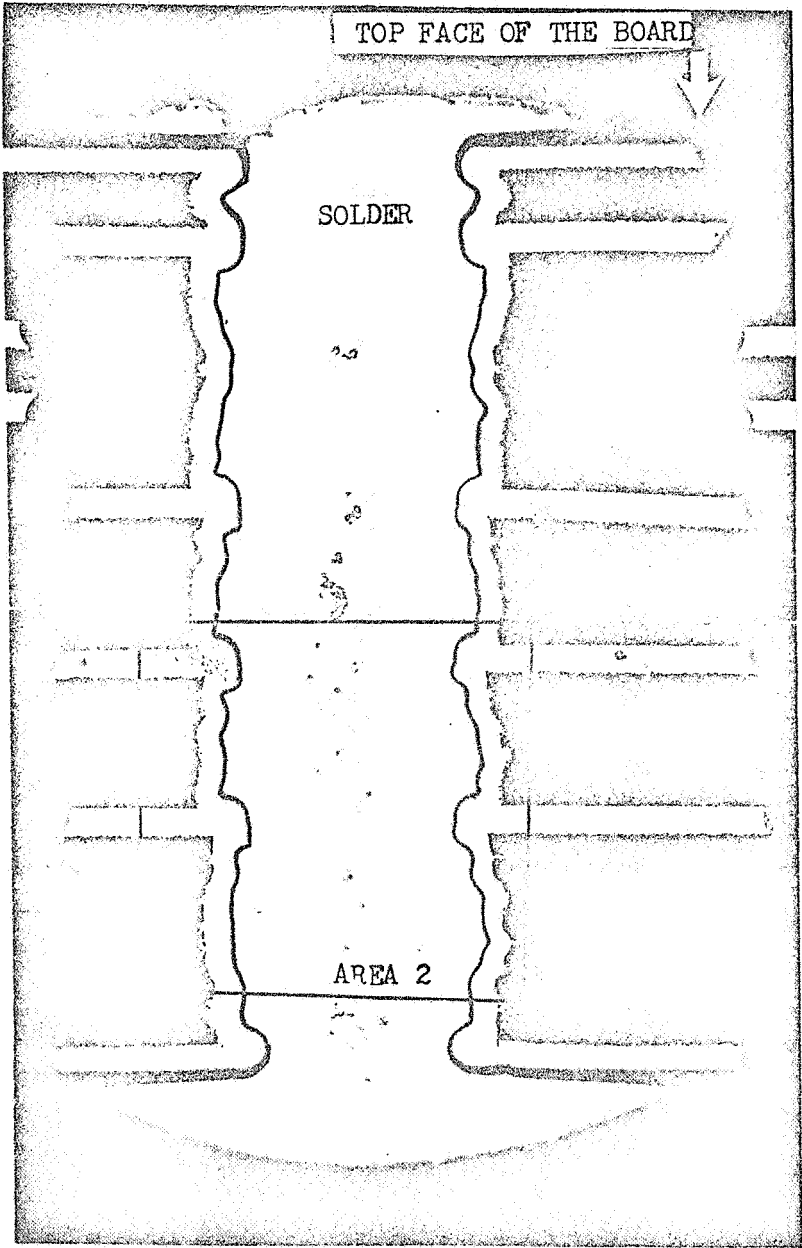
FIGURE 3

CONNECTION B SHOW

ING COMPLETE SOLDER FLOW

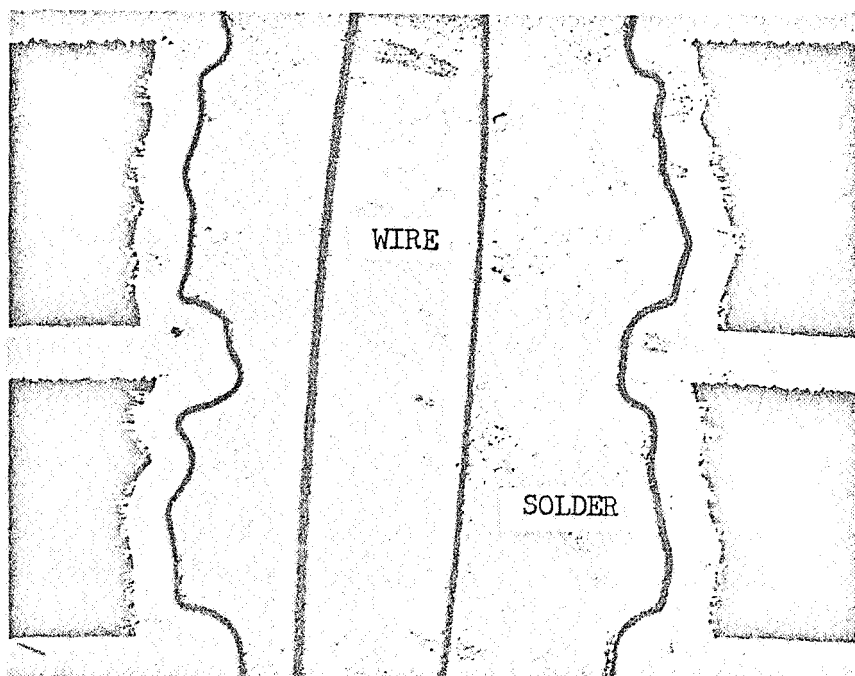
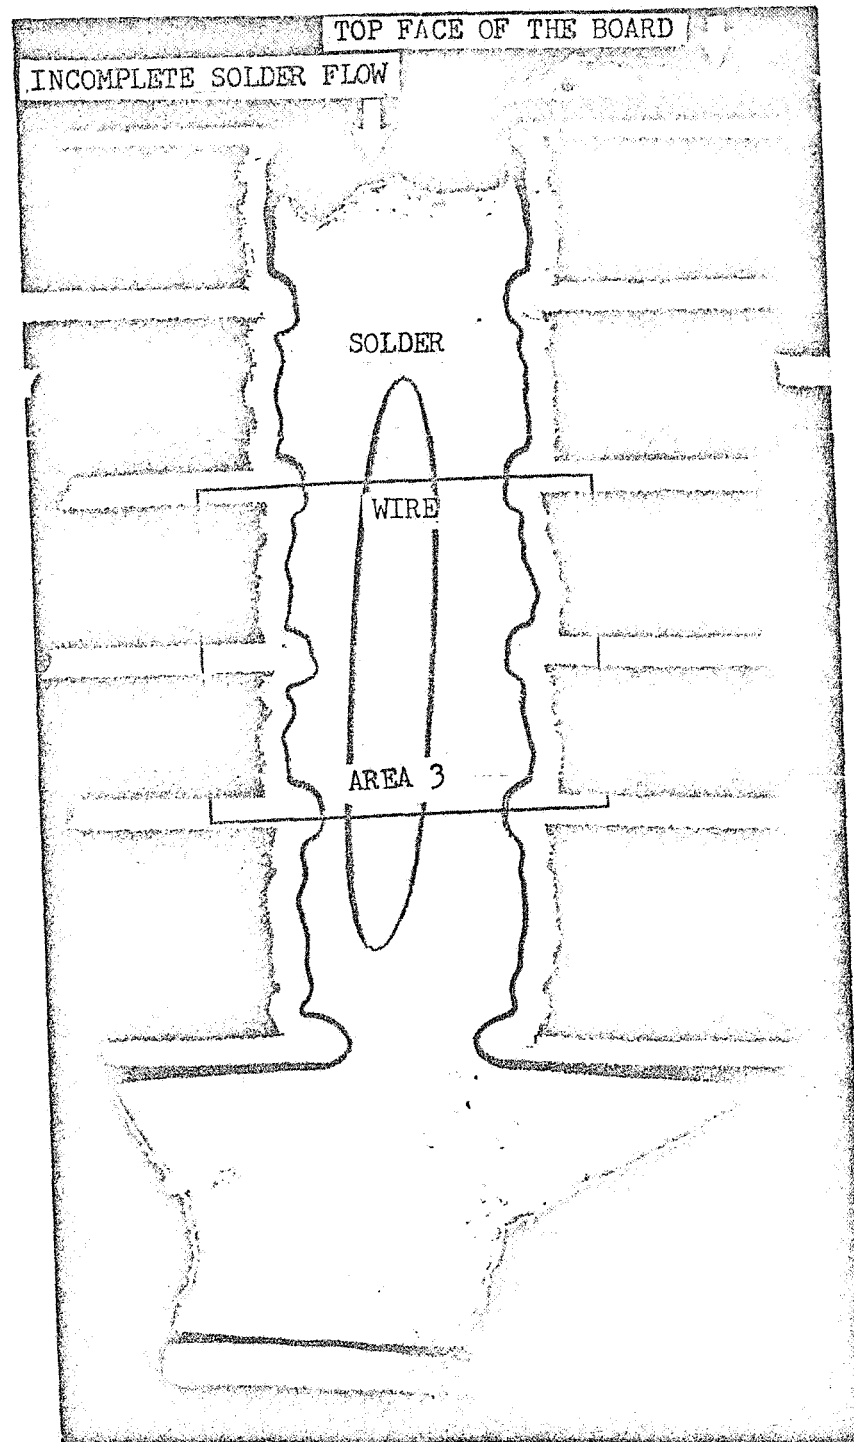
FIGURE 4

1. Connections C, DE, and F showed incomplete solder flow as shown in Figures 4, 5, and 6, respectively.
2. Hole "U" (designated as the unsoldered hole), which had been copper-tin-lead plated but which did not have a solder connection, showed evidence of a void in the solder plate and a crack in the copper plate. This condition is shown in Figure 10 on page 13. Repolishing of the specimen confirmed that the copper plate was fractured 0.07 inch below the top face of the board, (Figure 11 on page 13).

CONNECTION C SHOWI

INCOMPLETE SOLDER FLOW

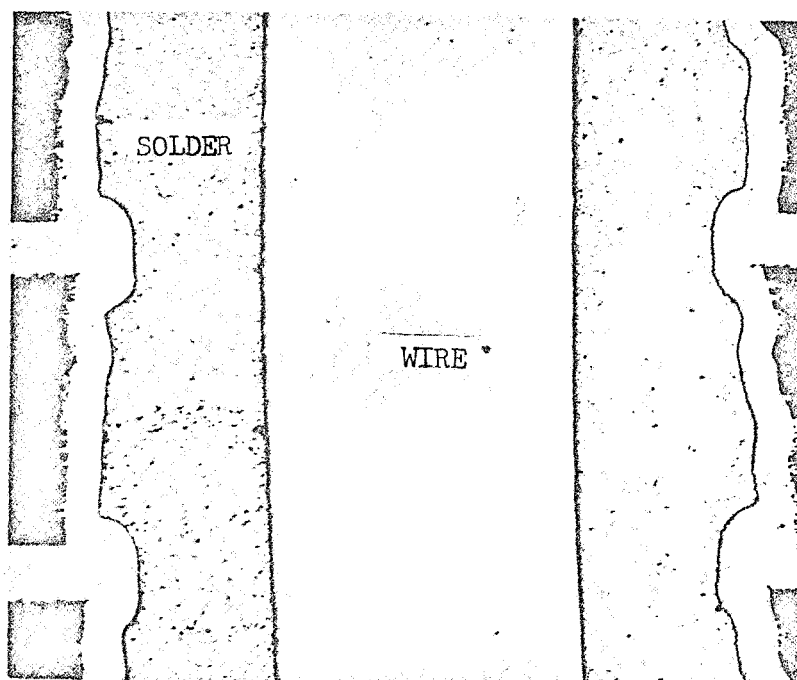
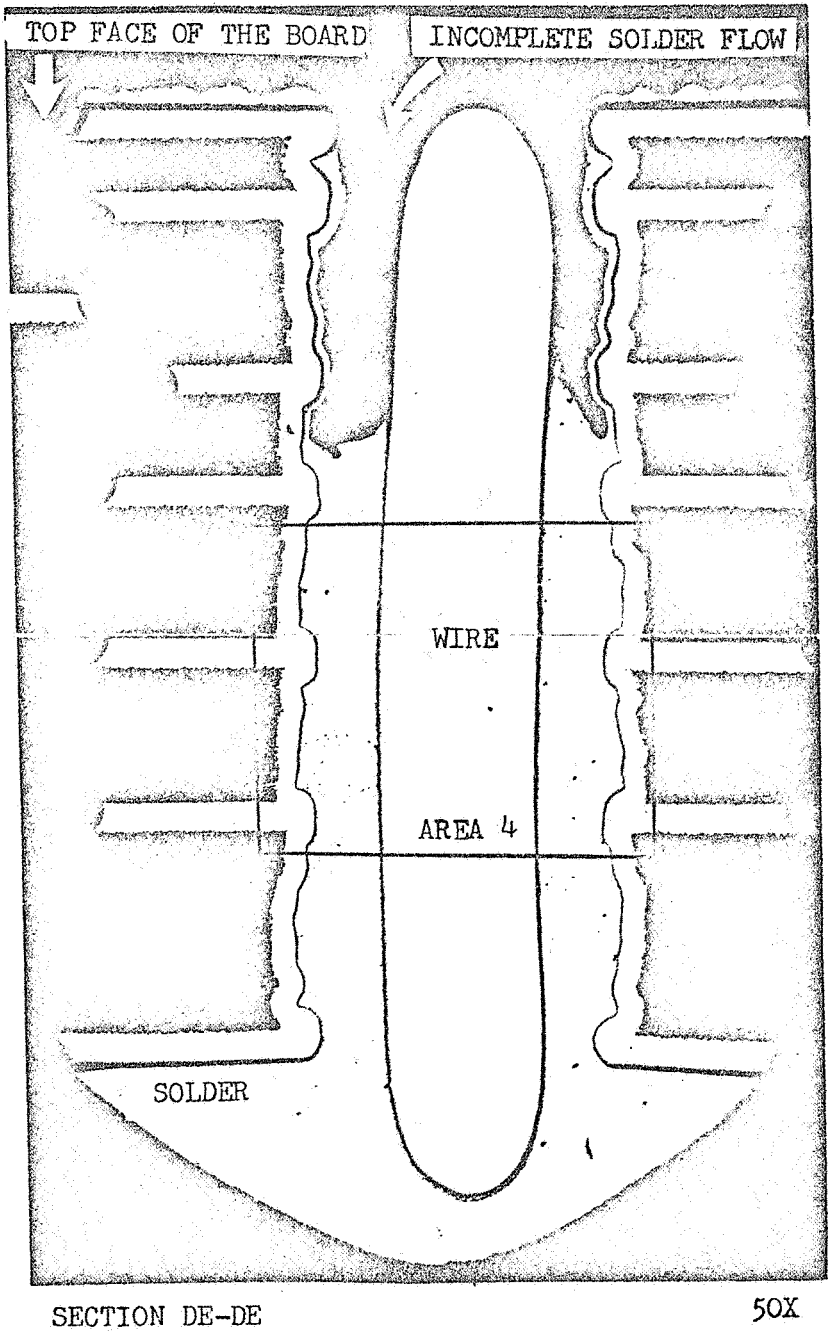
FIGURE 5

CONNECTION DE SHOWING

INCOMPLETE SOLDER FLOW

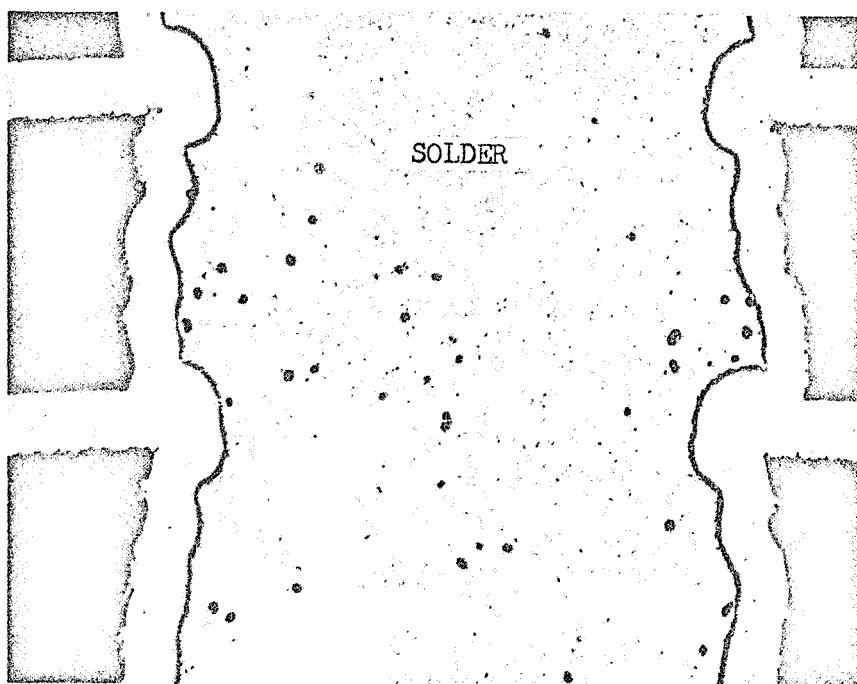
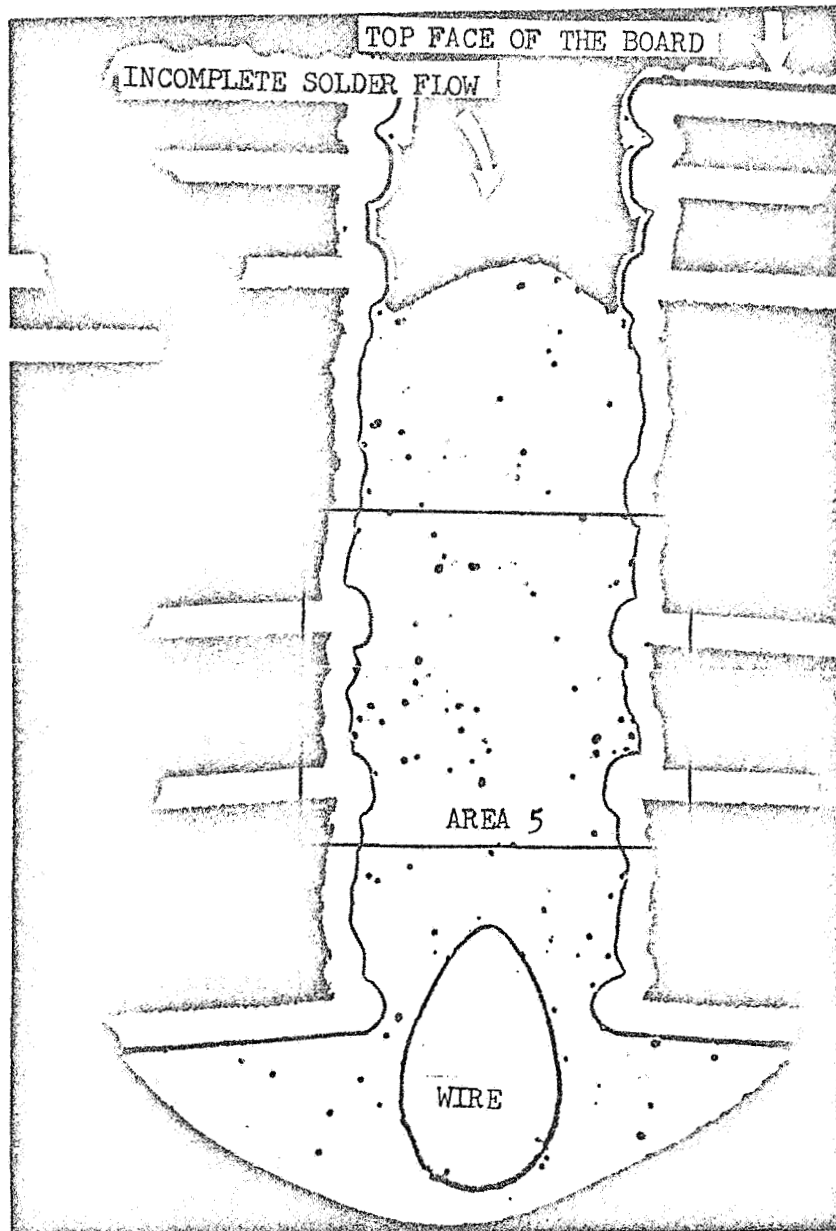
COMPLETE SOLDER FLOWFIGURE 6

CONNECTION F SHOWING

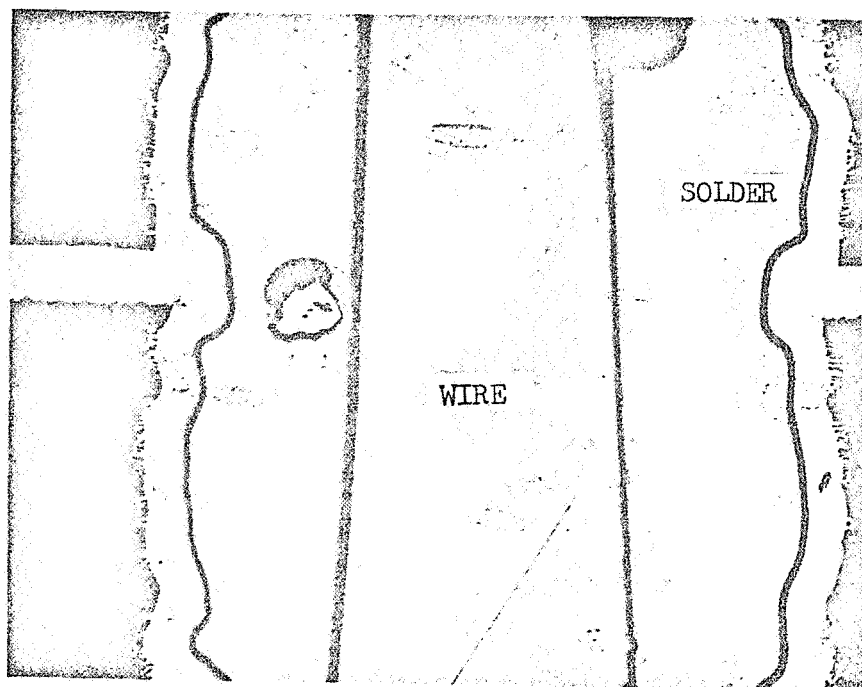
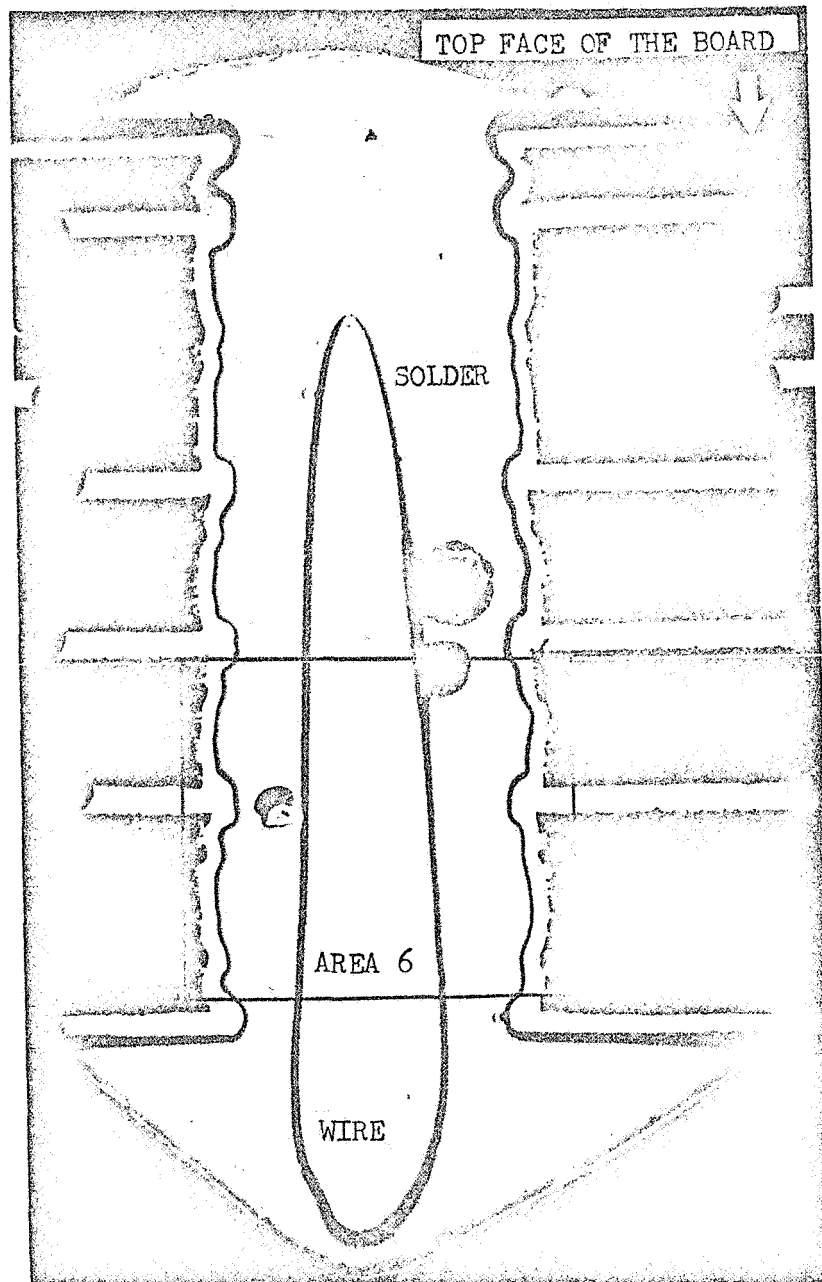
FIGURE 7

CONNECTION H1 SHOW
EXCEPT FOR

COMPLETE SOLDER FLOW
DS ALONG WIRE

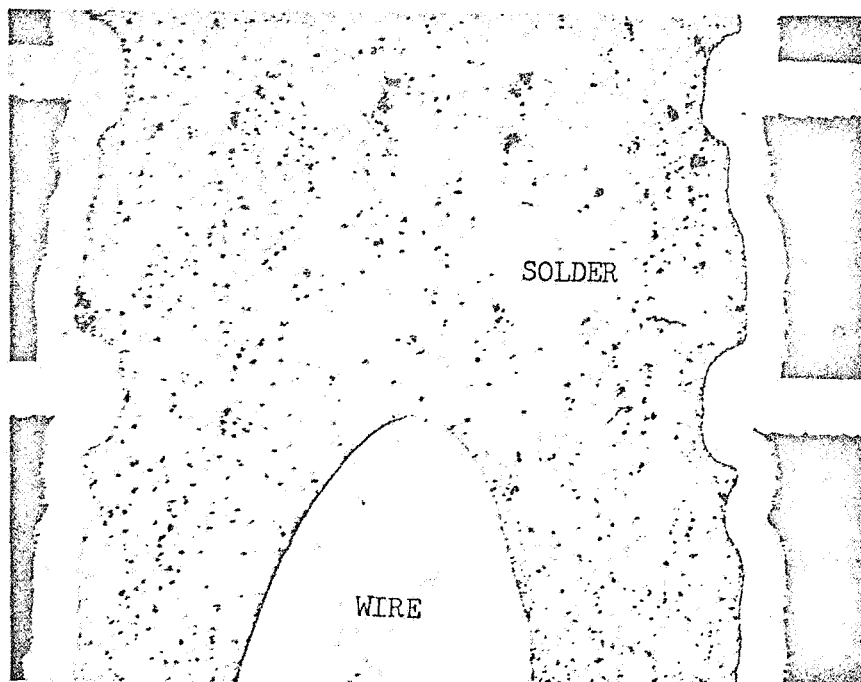
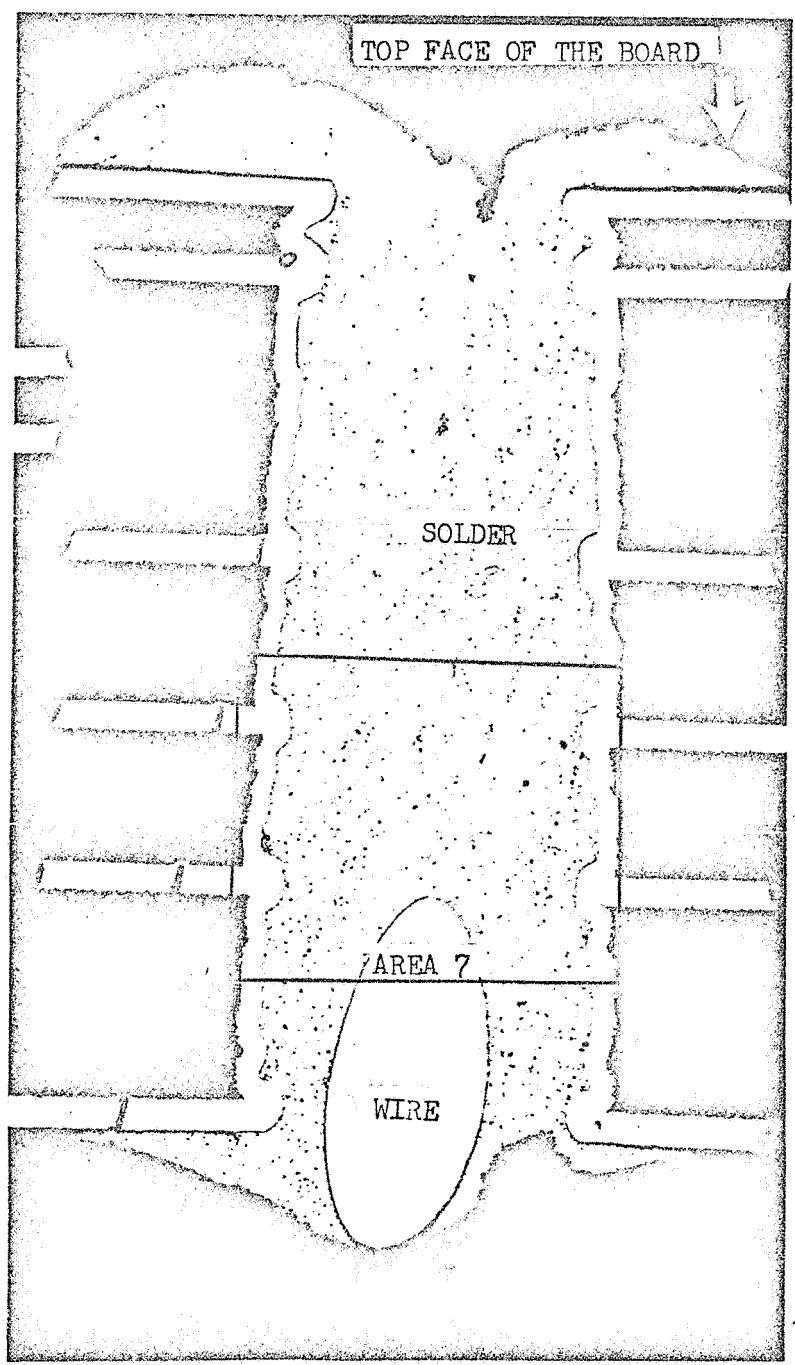
FIGURE 8

CONNECTION H2 SH

COMPLETE SOLDER FLOW

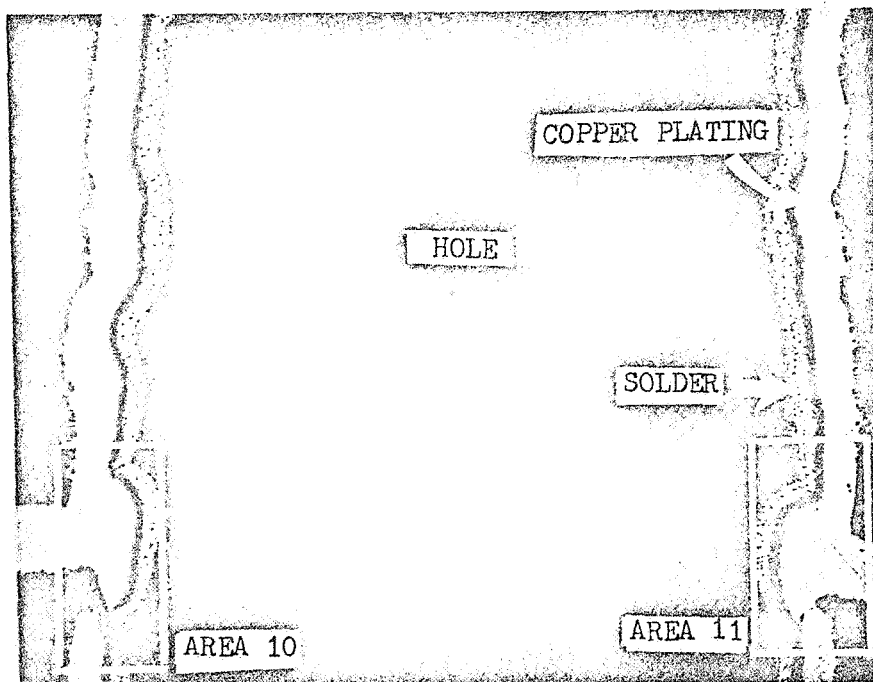
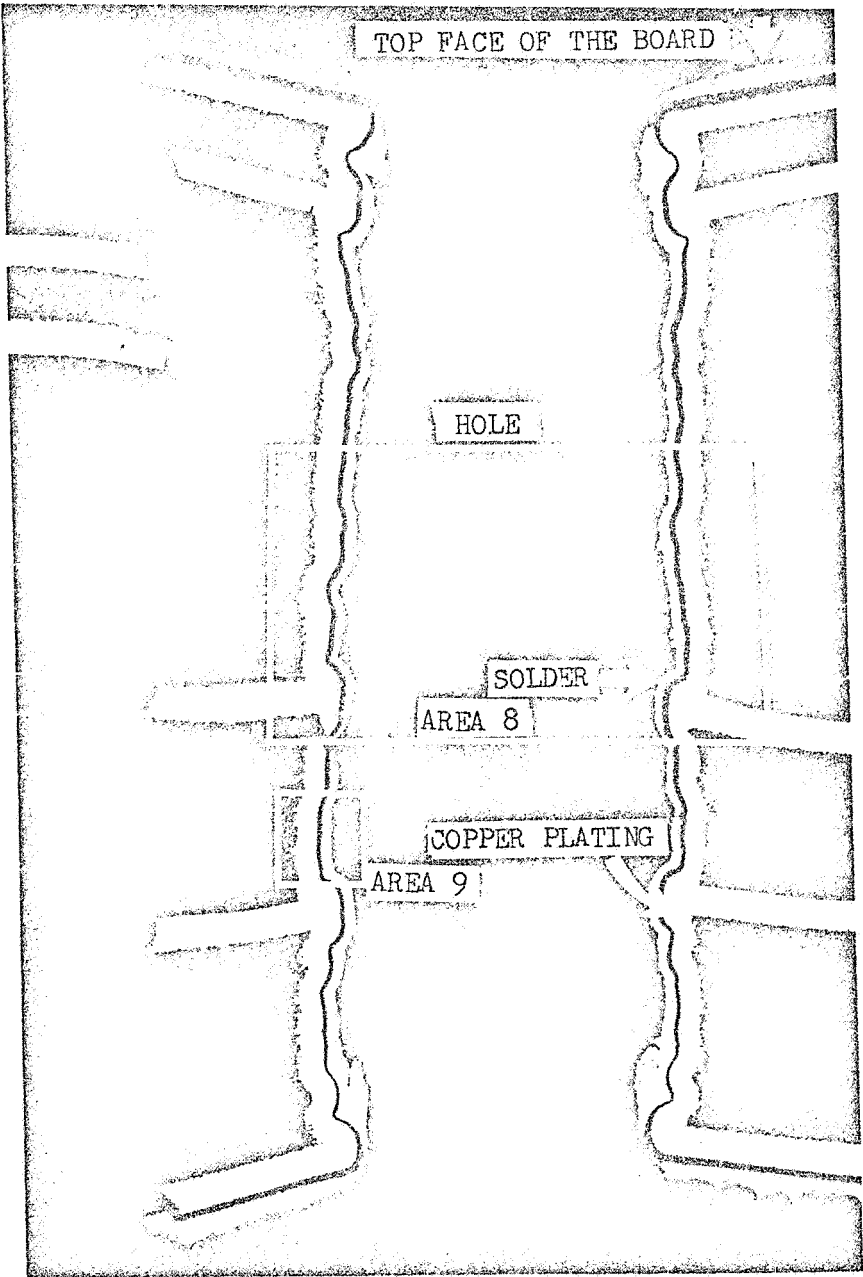
FIGURE 9

UNSOLDERED HOLE

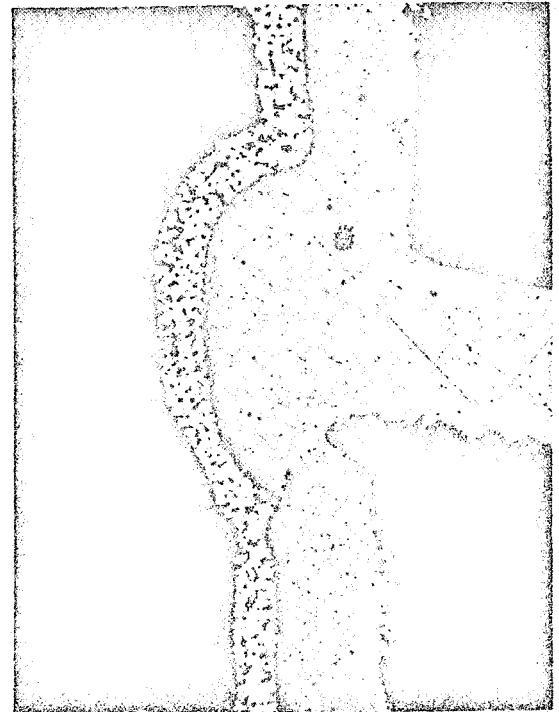
Area 11, Crack in
Copper Plate (arrow)

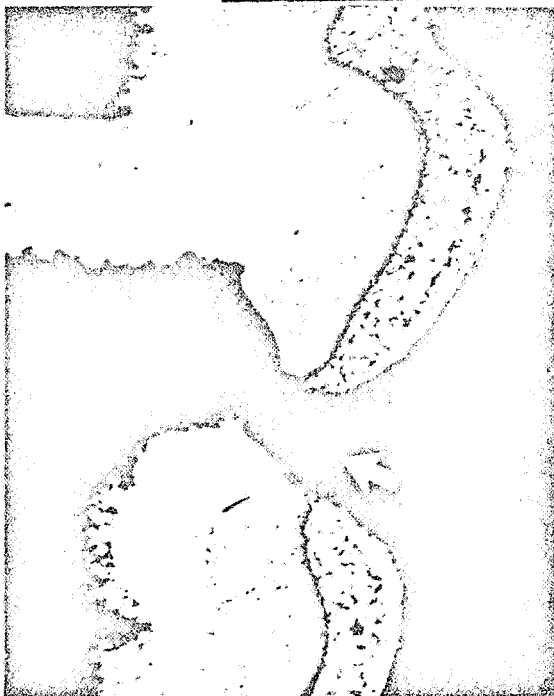
FIGURE 11 SAME AREAS AS FIGURE 10 AFTER REPOLISHING

Area 10, Break in
Copper Plate (arrow)

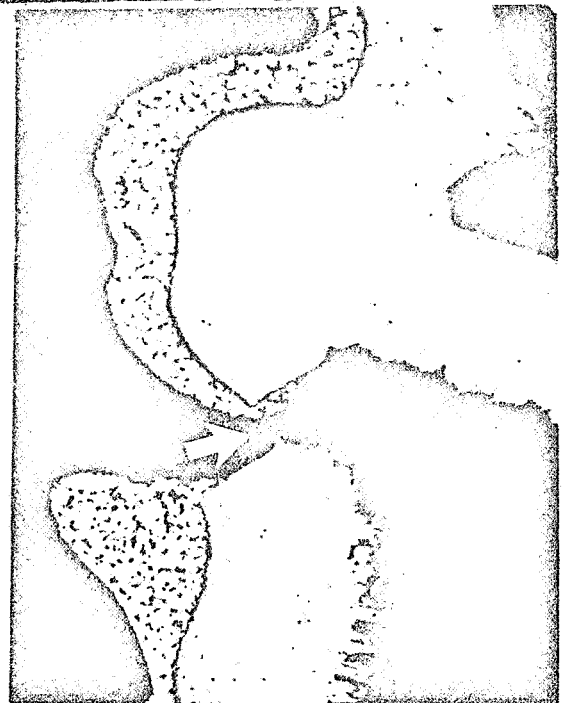
Area 11, Break
In Copper Plate (arrow)

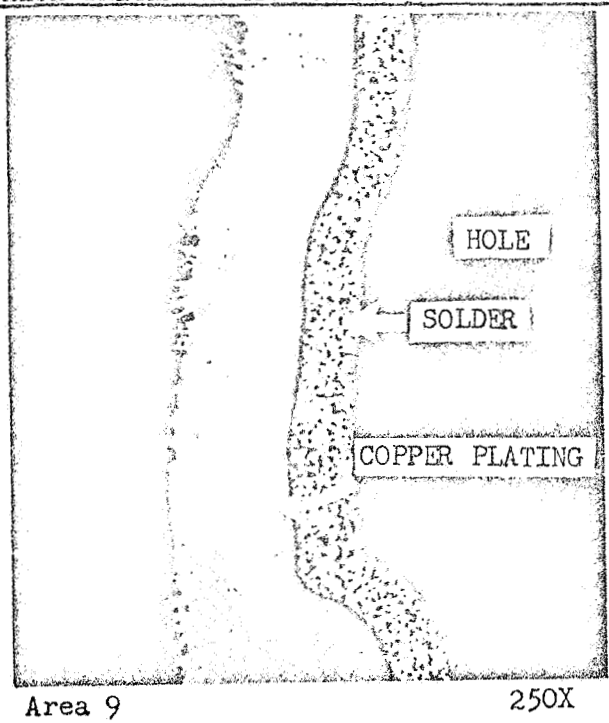
FIGURE 12-AREA OF SECTION U-U FROM WHICH THICKNESS MEASUREMENTS WERE TAKEN

3. Thickness measurements of the solder layer and the copper plate were made on the unsoldered hole from the photomicrograph in Figure 13 on page 13. The thicknesses were as follows: average copper plate-0.0024 inch, solder layer-0.0013 inch.
